THE PROGRESS REPORT OF REBUILDING OF
MANIMANDAPA PATI SOUTH
AT PATAN DARBAR SQUARE

A project of the
KATHMANDU VALLEY PRESERVATION TRUST
in Cooperation with
DEPARTMENT OF ARCHAEOLOGY

June 2016

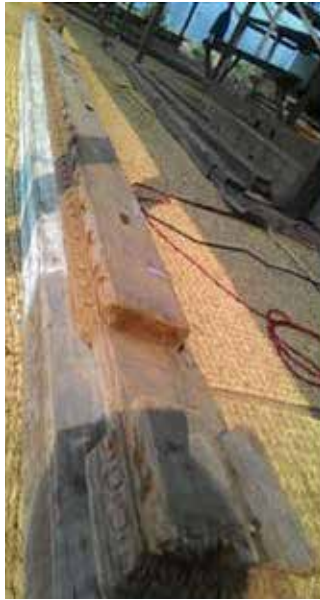
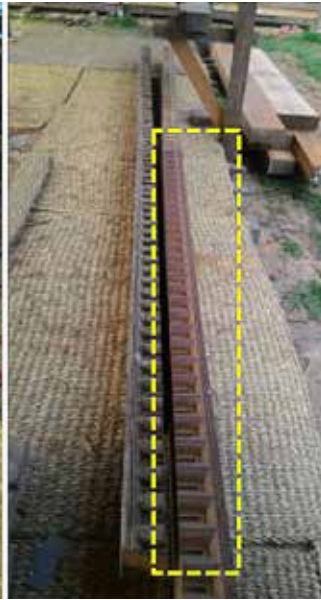
Manimandapa Pati South | March 28, 2016
Parts of cornices that were damaged from April 25, 2015 devastating earthquake were replicated and repaired for rebuilding. Repaired parts are in light color.

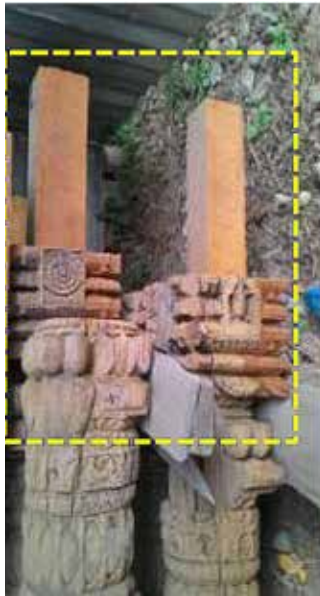
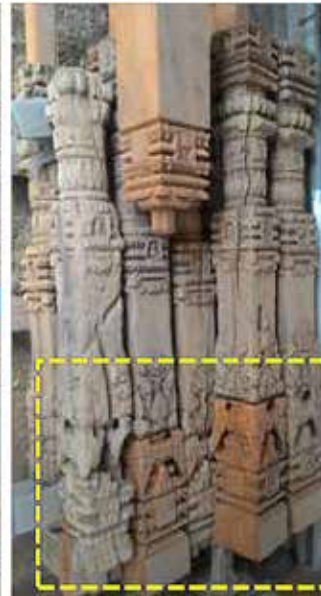
Manimandapa Pati South | March 28, 2016
Carved columns that got deteriorated by time and damaged during the devastating earthquake of April 25, 2015 were replicated, repaired and strengthened for rebuilding the Pati.

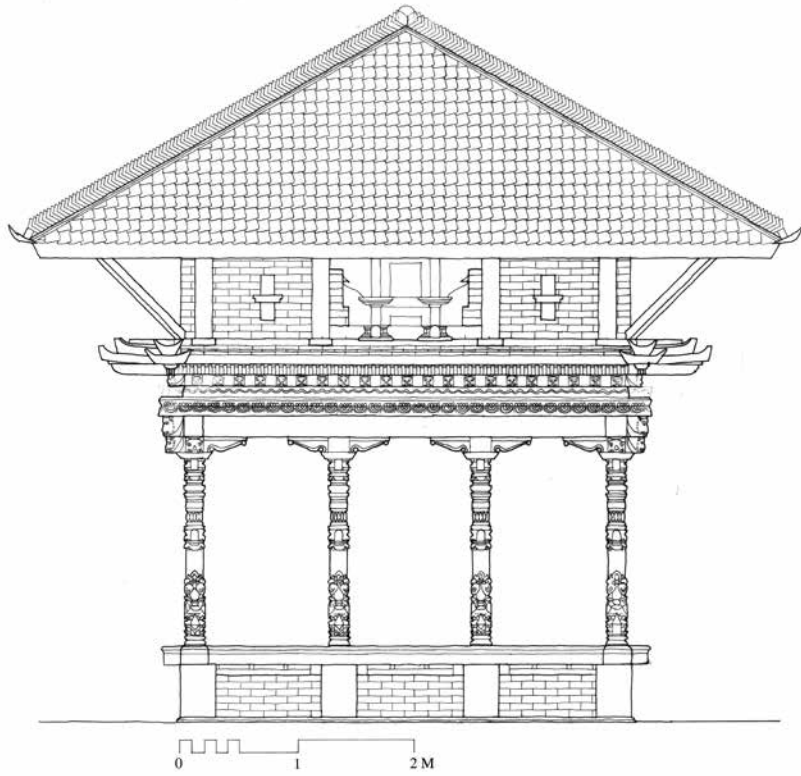
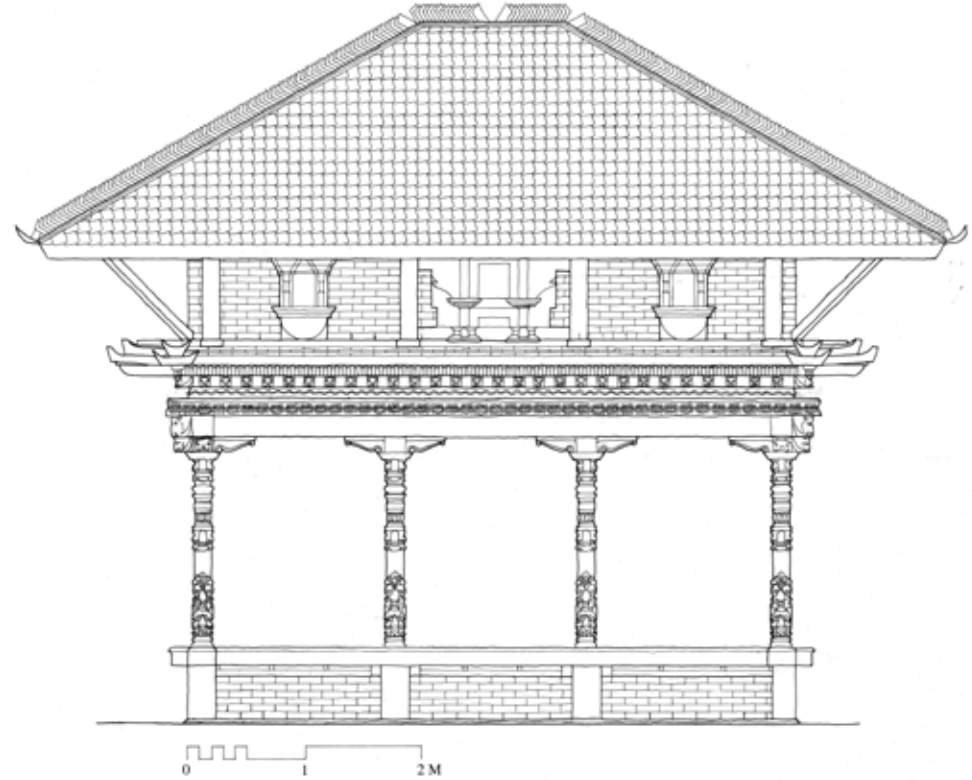
Manimandapa Pati South | April 01, 2016
South North and East West elevation drawings are made by hand as part of documentation.

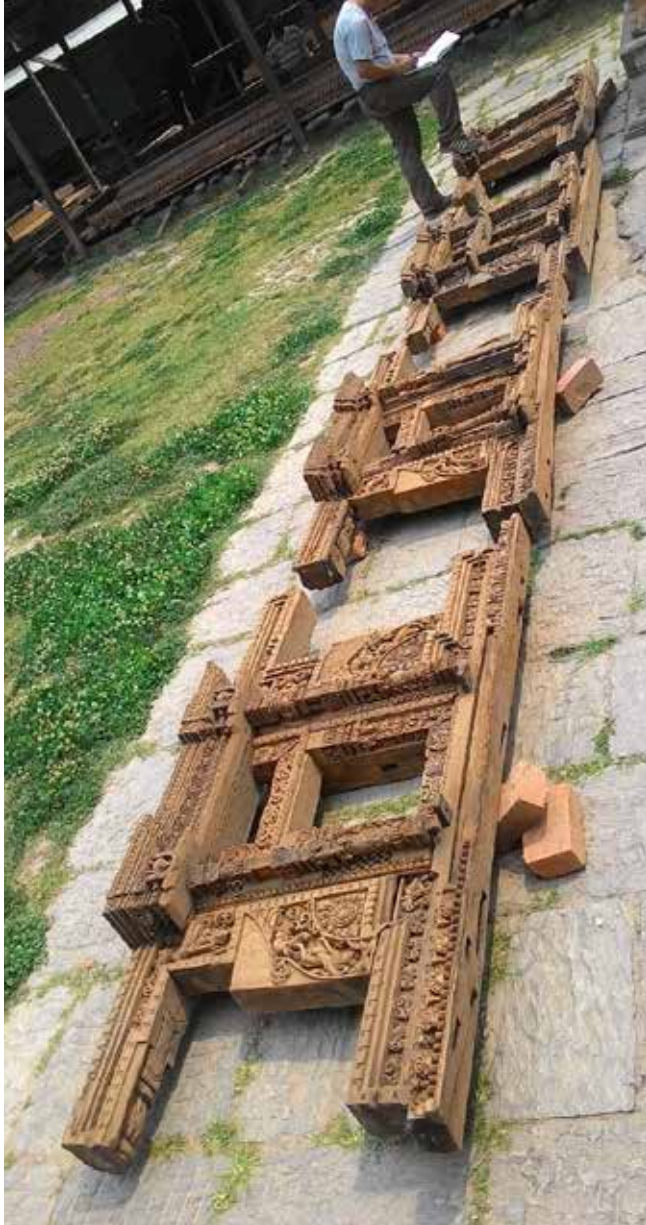
Manimandapa Pati South | April 06 2016
The windows that were cleaned and stored were assembled to identify the missing parts for replication and repair work.

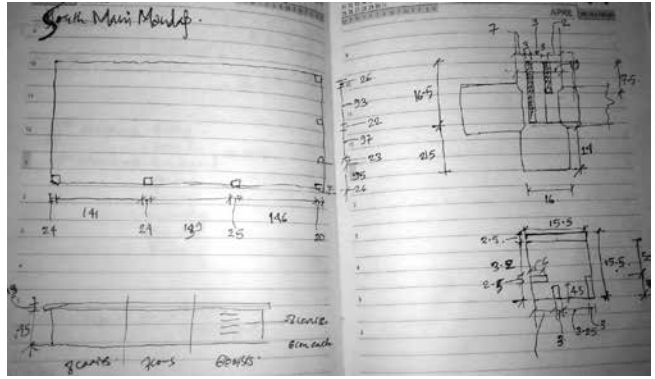
Manimandapa Pati South | April 08 2016
Detailed measurements of windows and floor plans were carried out at storeroom and site.

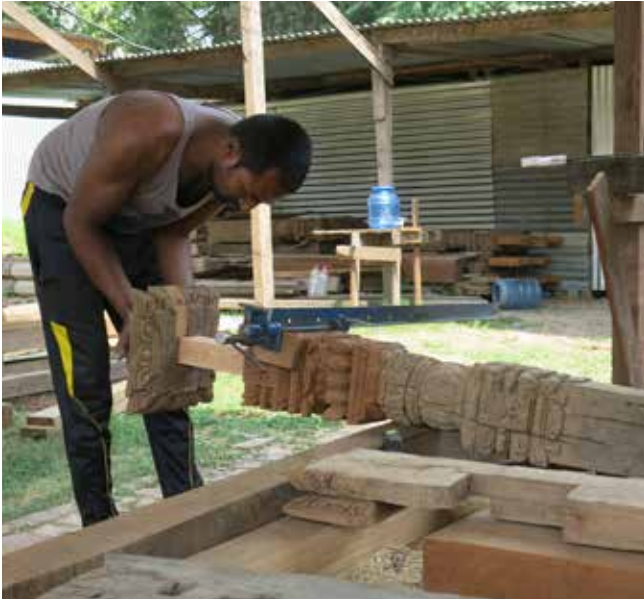
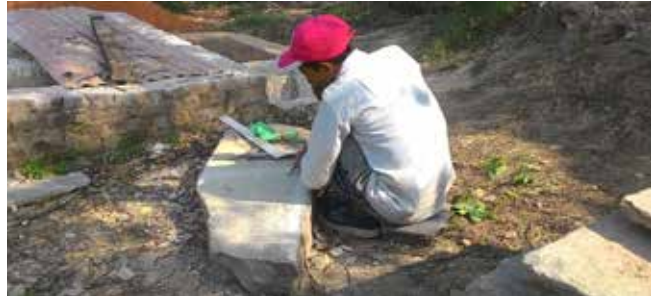
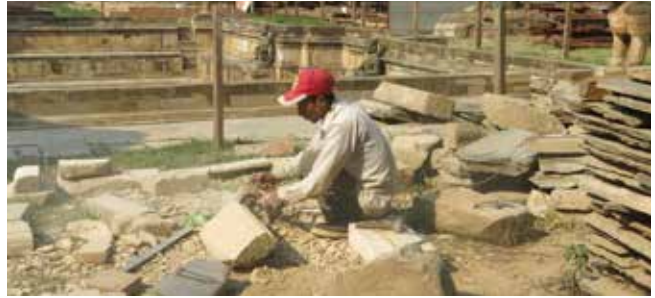
Manimandapa Pati South |
Carpenter adding tenon to the repaired pillar. Stone mason chiseling and sizing the stone for making quarter round (*nagol*) on the top edge.

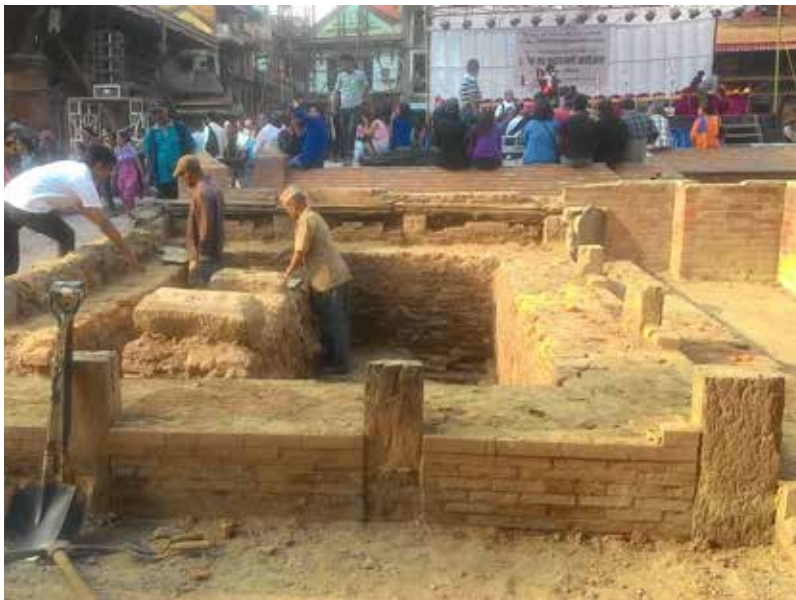
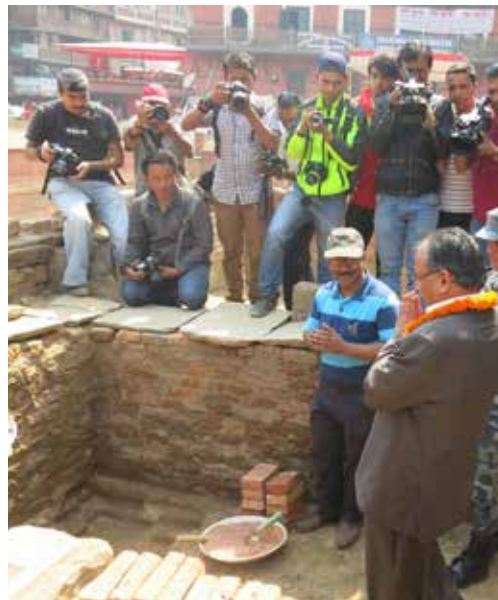
Manimandapa Pati South | April 24 & 25, 2016
Ground floor of the Pati was excavated and trash cleared from site. Former Prime Minister Mr. Puspa Kamal Dahal (Prachanda) inaugurated the rebuilding of Pati by laying foundation brick on northeast corner on April 25, 2016. This inauguration initiated the over all reconstruction of monuments and houses that was destroyed by devastating earthquake of April 25, 2015.

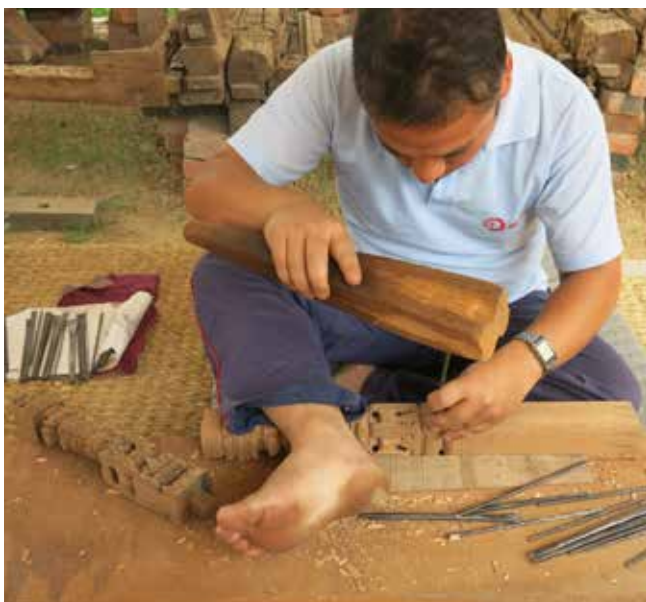
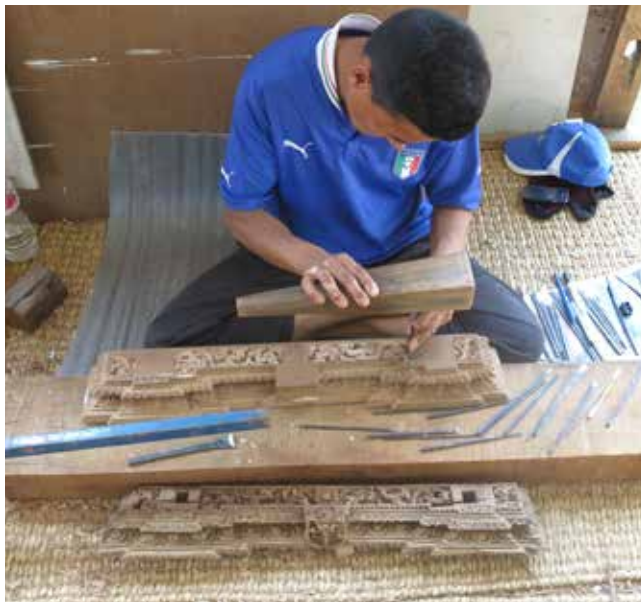
Manimandapa Pati South | April 25 & 29, 2016
Woodcarvers replicating the missing parts of the windows of the Pati such as pillar and *kulah*.

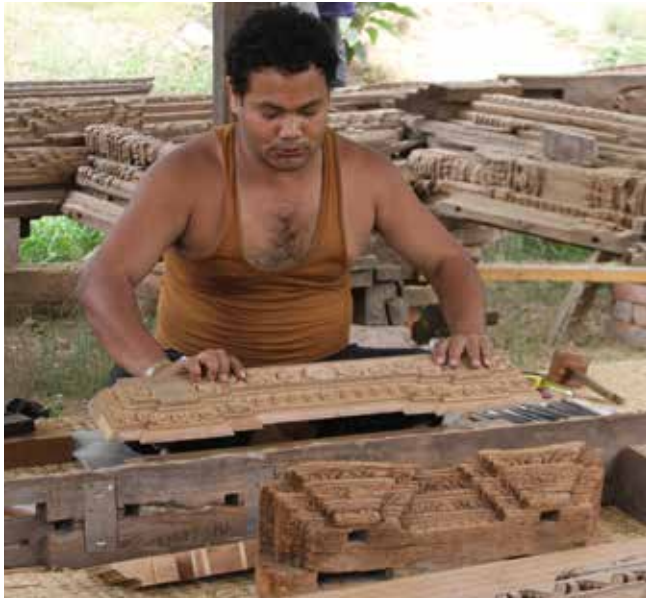
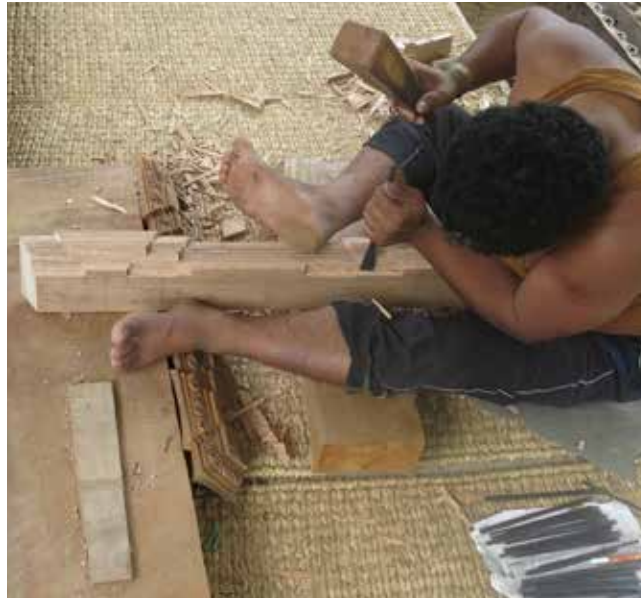
Manimandapa Pati South | May 02 and 05, 2016
Woodcarvers replicating the window cornice *kulah*.

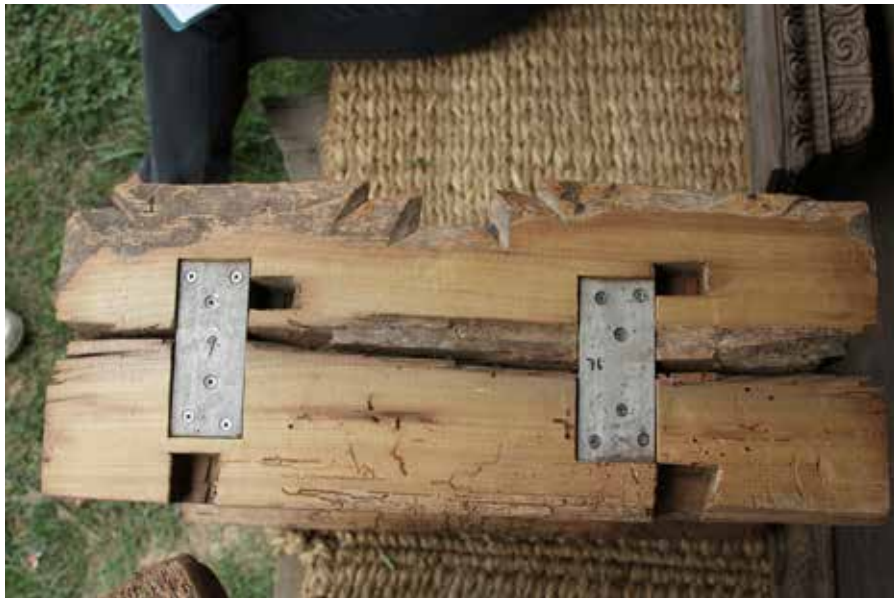
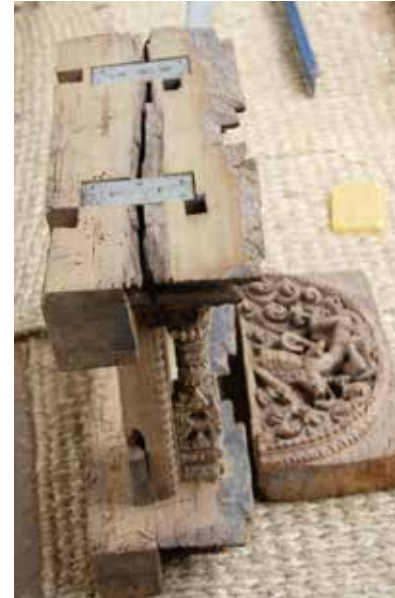
Manimandapa Pati South | May 05, 2016
Broken *kulah* (cornice) of the window is being joined with the stainless steel plate and screws. Steel plates are used only for joining the completely broken pieces only.

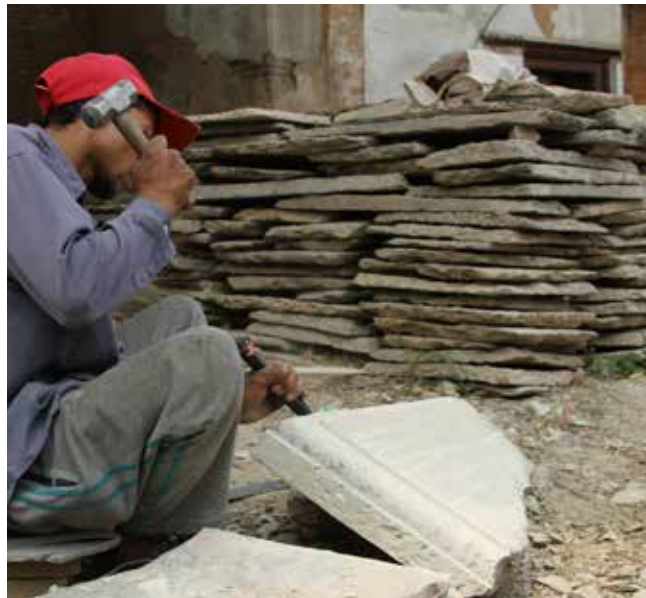
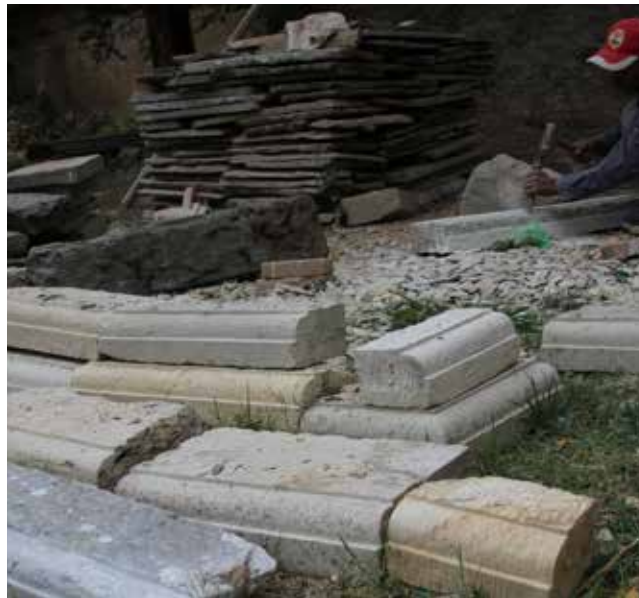
Manimandapa Pati South | May 05, 2016
Stone mason making quarter round (*nagol*) by chiseling the stone on top edge.

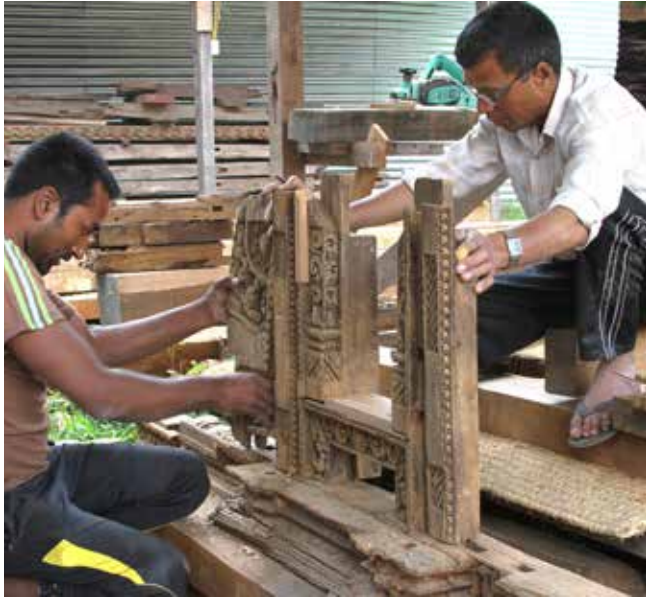
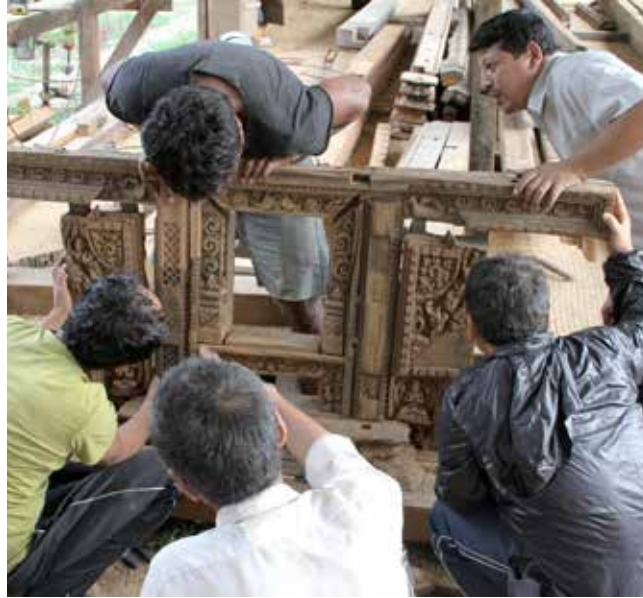
Manimandapa Pati South | May 08, 2016
Carpenters and woodcarvers (Tirtha Ram Silpakar and friends) assembling one of the four large windows after damaged parts were replicated and repaired.

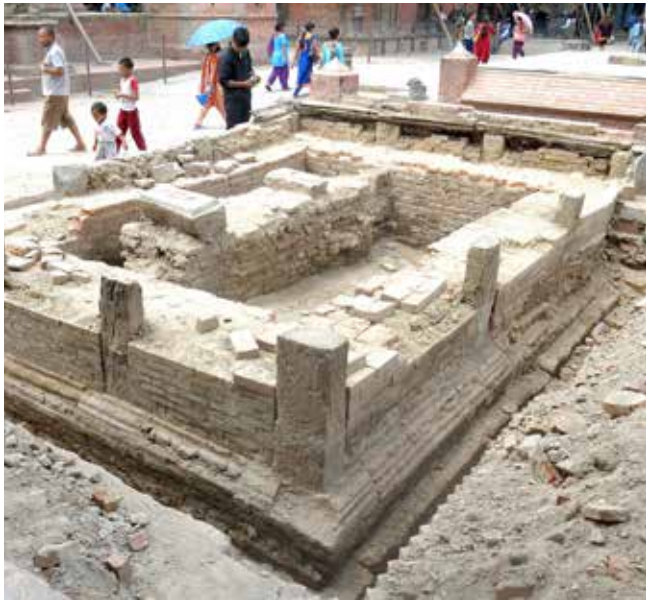
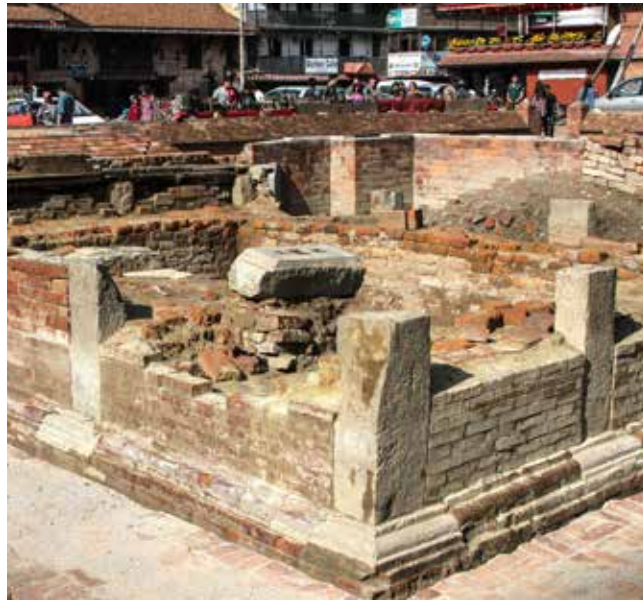
Manimandapa Pati South | May 08 & 12, 2016
Later period brick pavement removed and excavation was carried out around the Pati's plinth to check the condition of foundation where the original brick and stone nagol (bead) were discovered and now it is exposed.

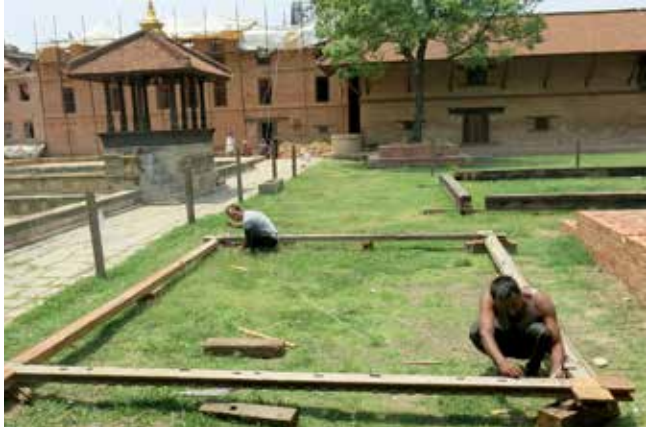
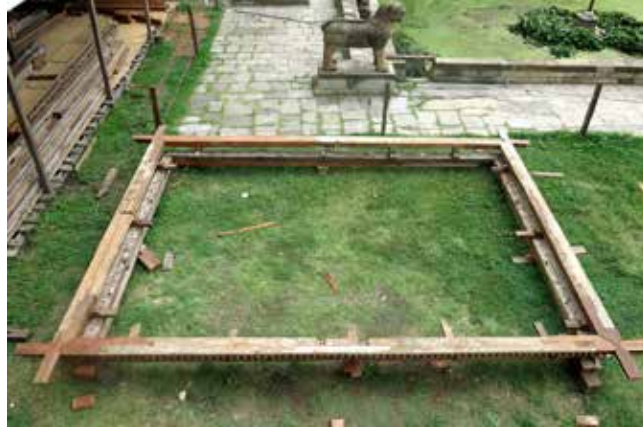
Manimandapa Pati South | May 17 & 20, 2016
The repaired and retrofitted cornices of all four side during and after completely assembled.

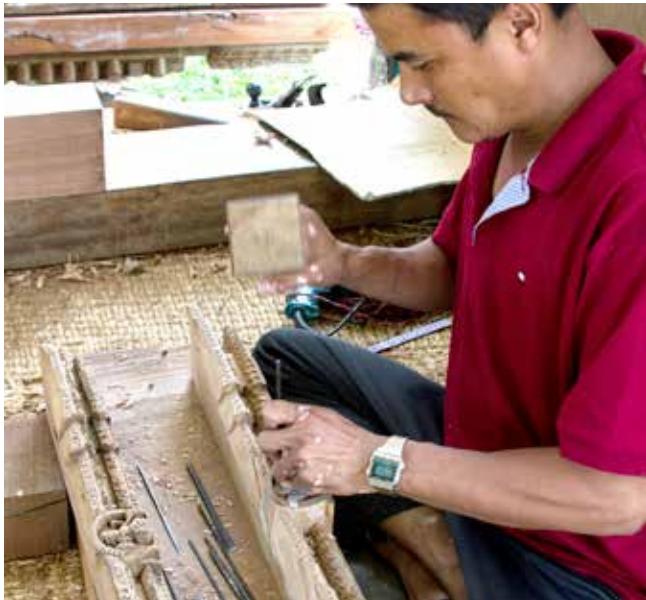
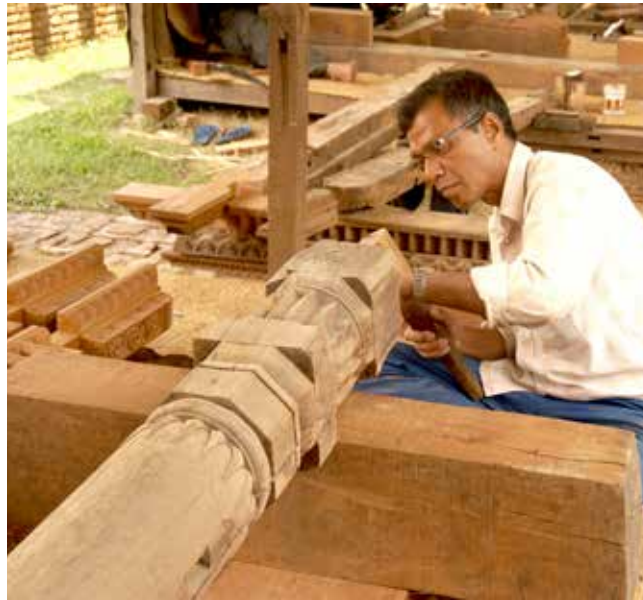
Manimandapa Pati South | May 17 & 20, 2016
Woodcarver Hari Prasad Silpakar replicating the deity as per the original large window's *kulan* and carpenter repairing the central column.

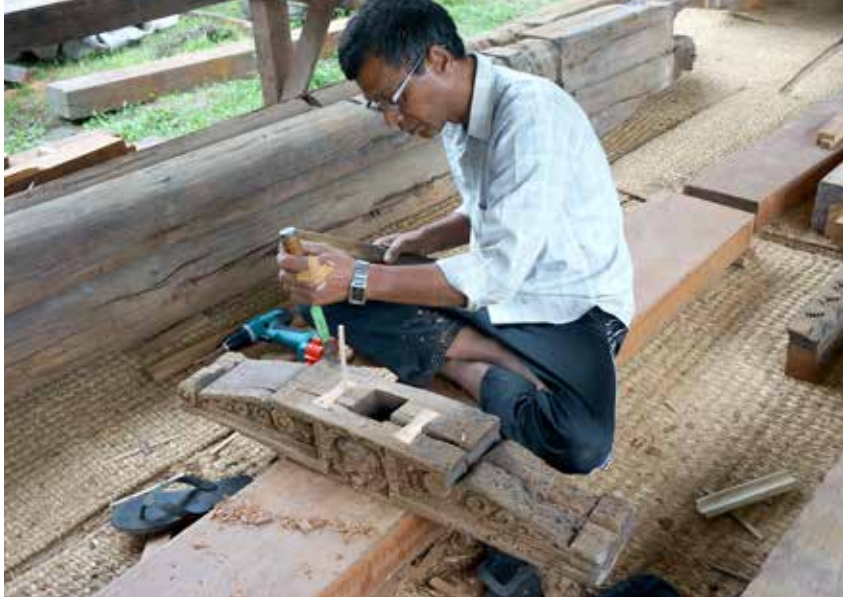
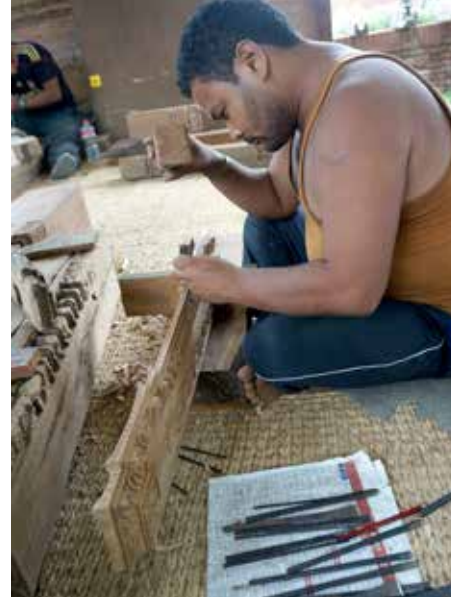
Manimandapa Pati South | May 24, 2016
Carpenter repairing and retrofitting the capital (*meth*) of the column using the traditional material wood including bamboo pegs. Woodcarver replicating the window cornice *kulah*.

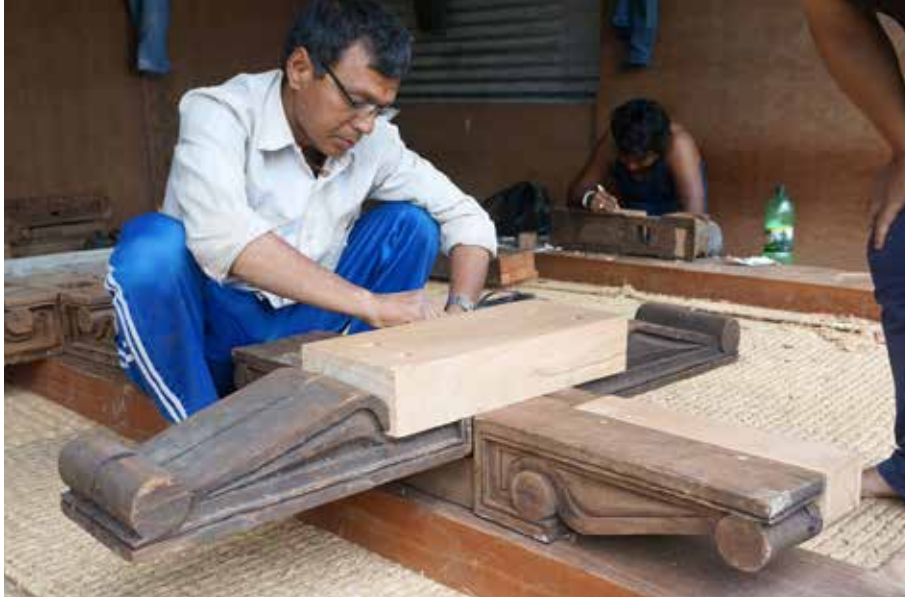
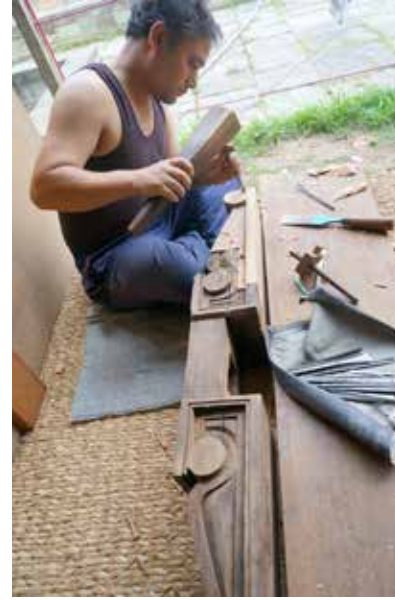
Manimandapa Pati South | May 30, 2016
Repairing, replicating and retrofitting of the central column capital (*meth*) are ongoing.

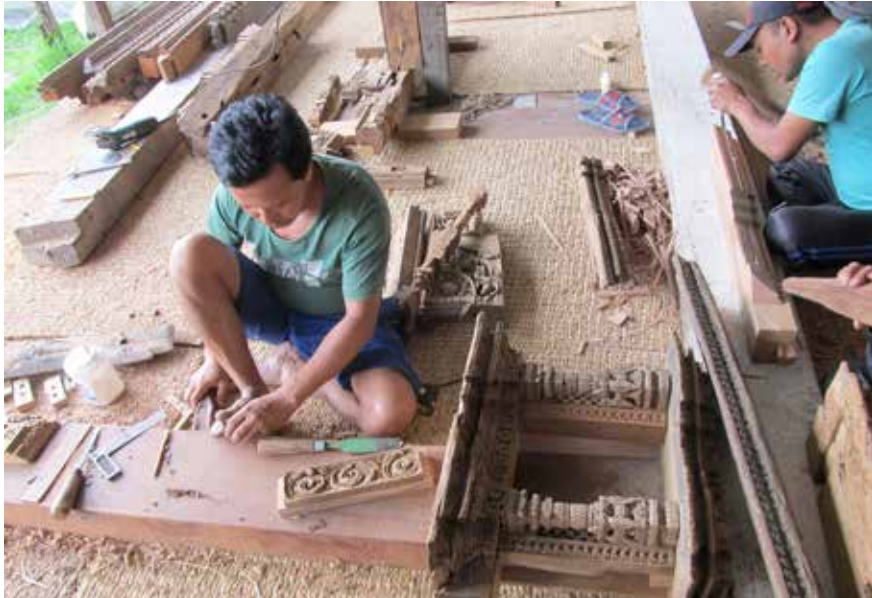
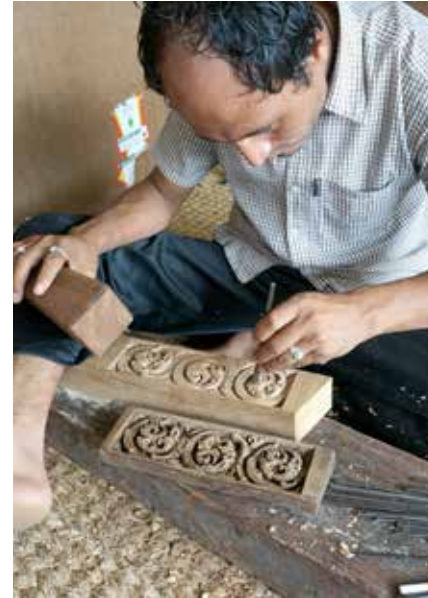
Manimandapa Pati South | May 29 & June 01, 2016
A window bracket of the south pati is being replicated including cornice (*kulah*) and window assembling.

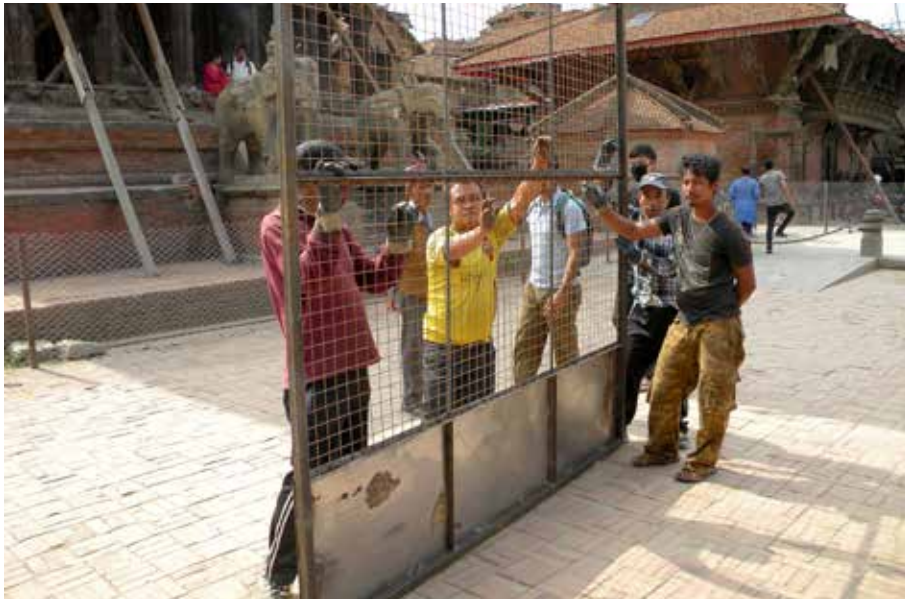
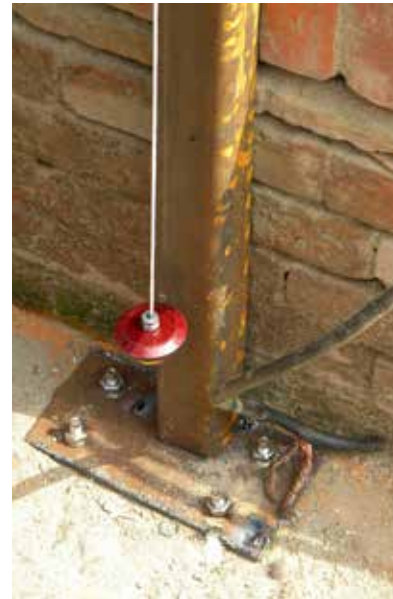
Manimandapa Pati South | June 07, 2016
Metal fencing is being initiated by installing plate on ground erecting square pipe post.

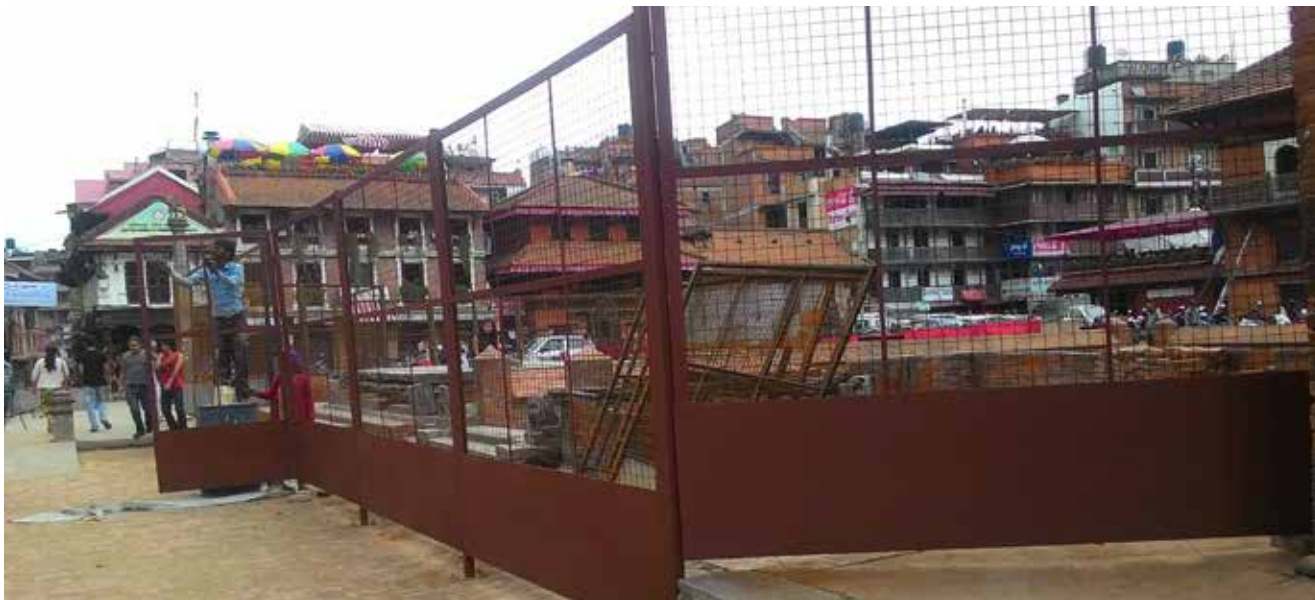
Manimandapa Pati South | June 21, 2016
Building of metal fencing completed around the Pati including red oxide painting.
